Rocky Flats Environmental Technology Site

PRE-DEMOLITION SURVEY REPORT (PDSR)

BUILDING 774 1973 ADDITION

April 14, 2004

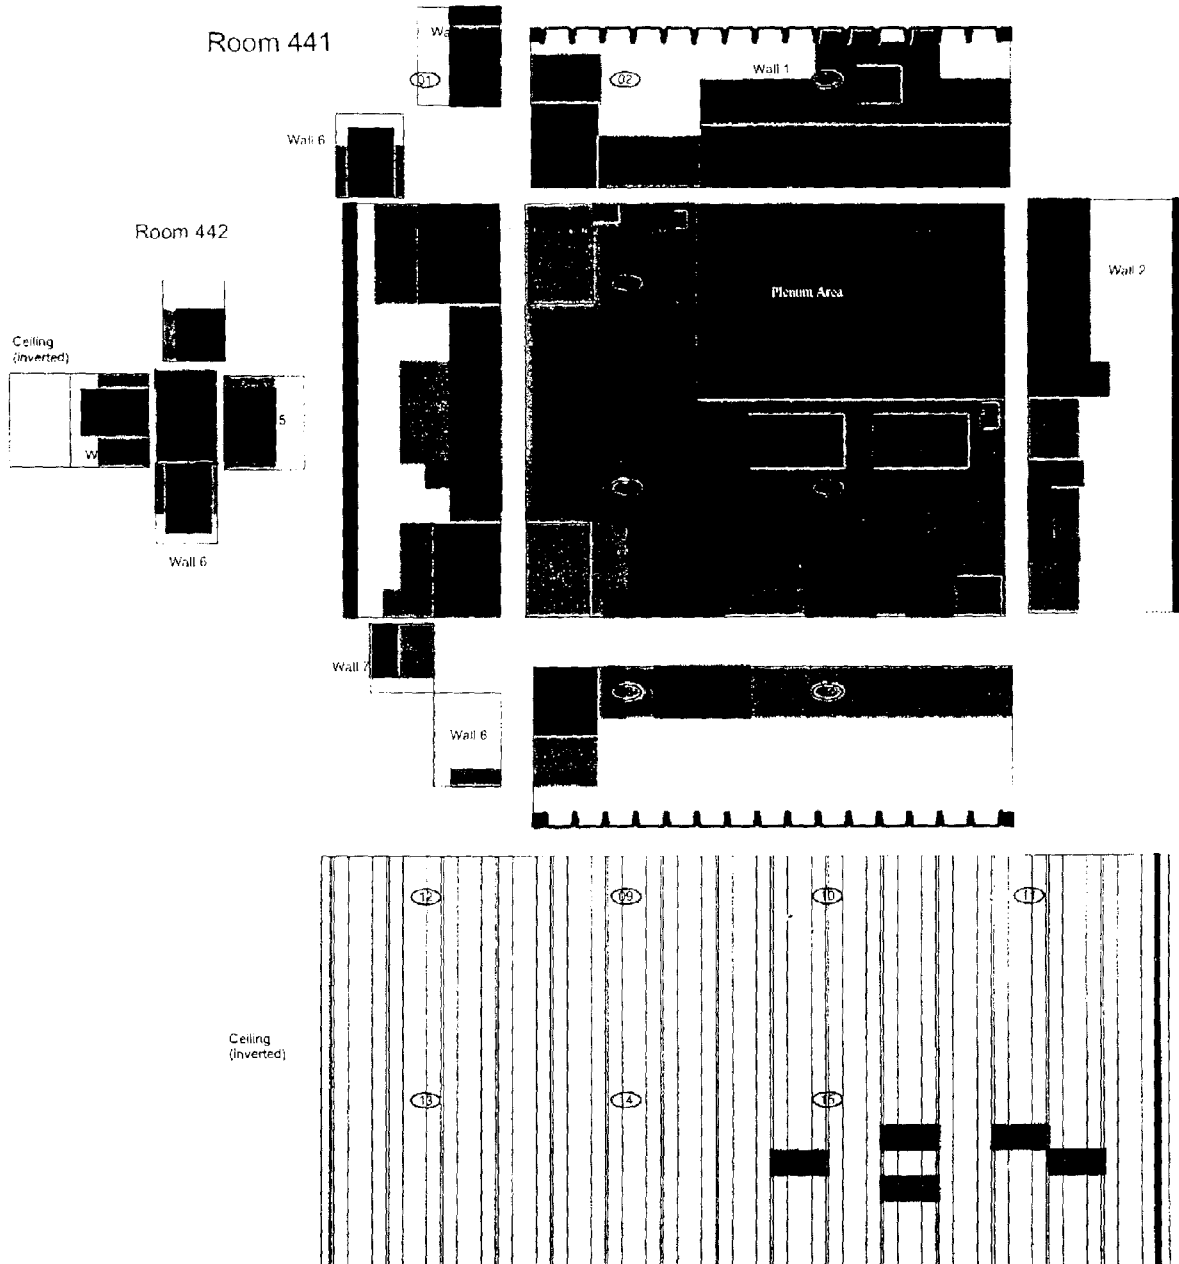
## **SURVEY UNIT 771057 - MAP 1 OF 1**

Total Floor Area: 186 sq. m      Total Area: 1169 sq. m      Grid Size: 8m x 8m

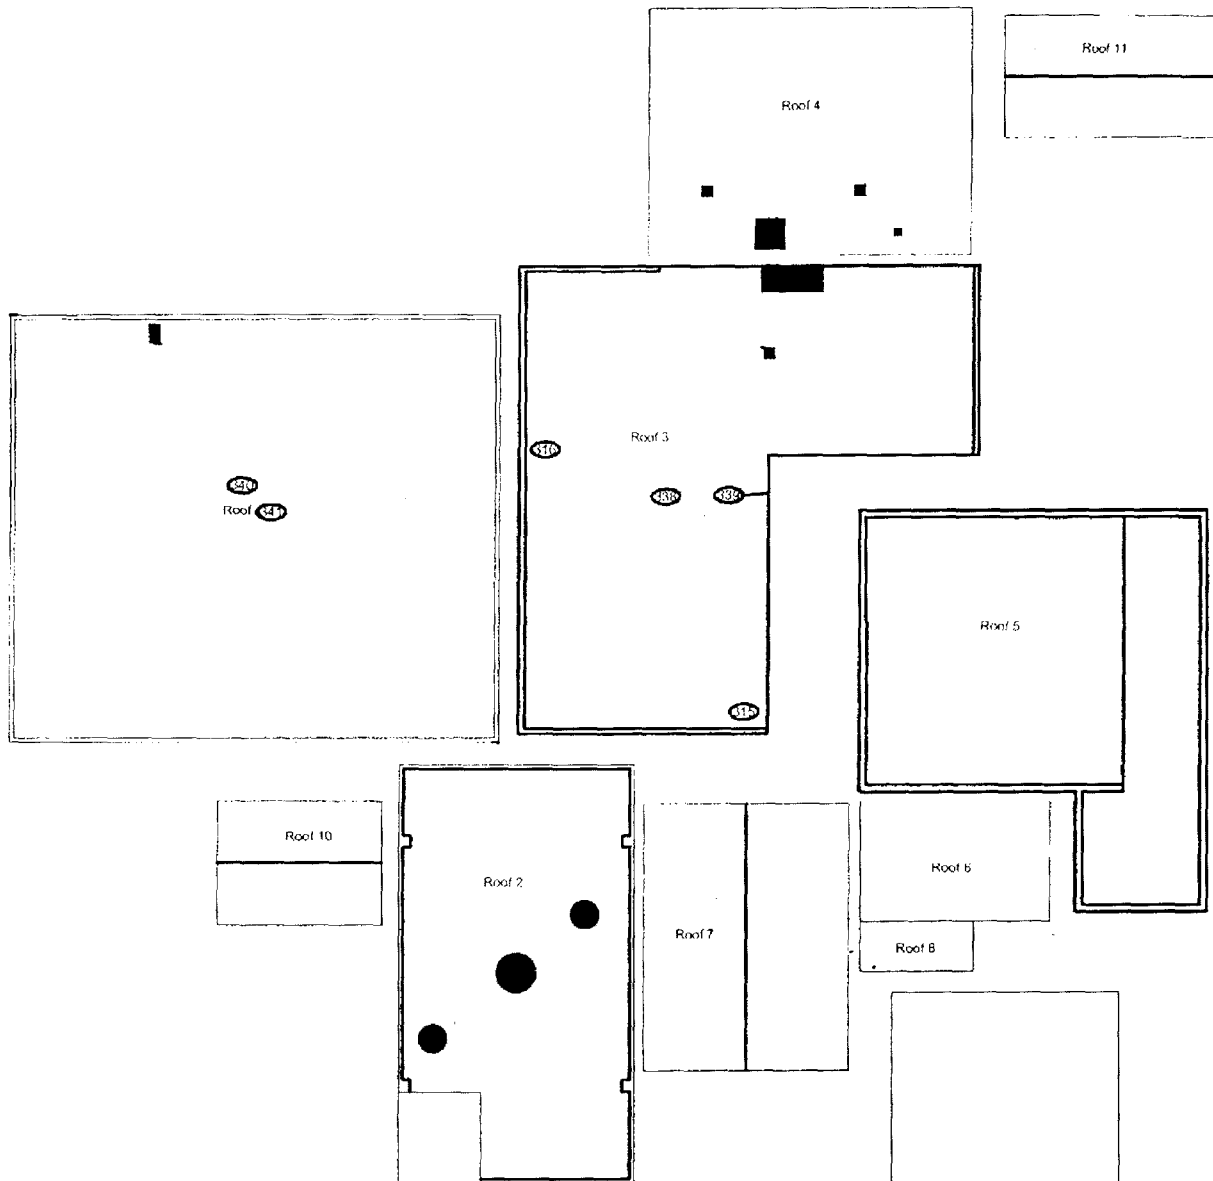
Description: Roof Complex

Location	Sample Number	Description	Result
MS-315	771-12-27-2000-MS-315	TSI mud on ch water pipe elbow	20.0% chry
MS-316	771-12-27-2000-MS-316	White TSI block on a steam pipe	23.0% chry
MS-338	771-01-04-2001-MS-338	Built up roofing	ND
MS-339	771-01-04-2001-MS-339	Silver painted roof flashing	6.0% chry
MS-340	771-01-04-2001-MS-340	Silver paint Black fibrous tar	6.0% chry 35.0% chry
MS-341	771-01-04-2001-MS-341	Silver painted lock	3.0% chry
